NOTE

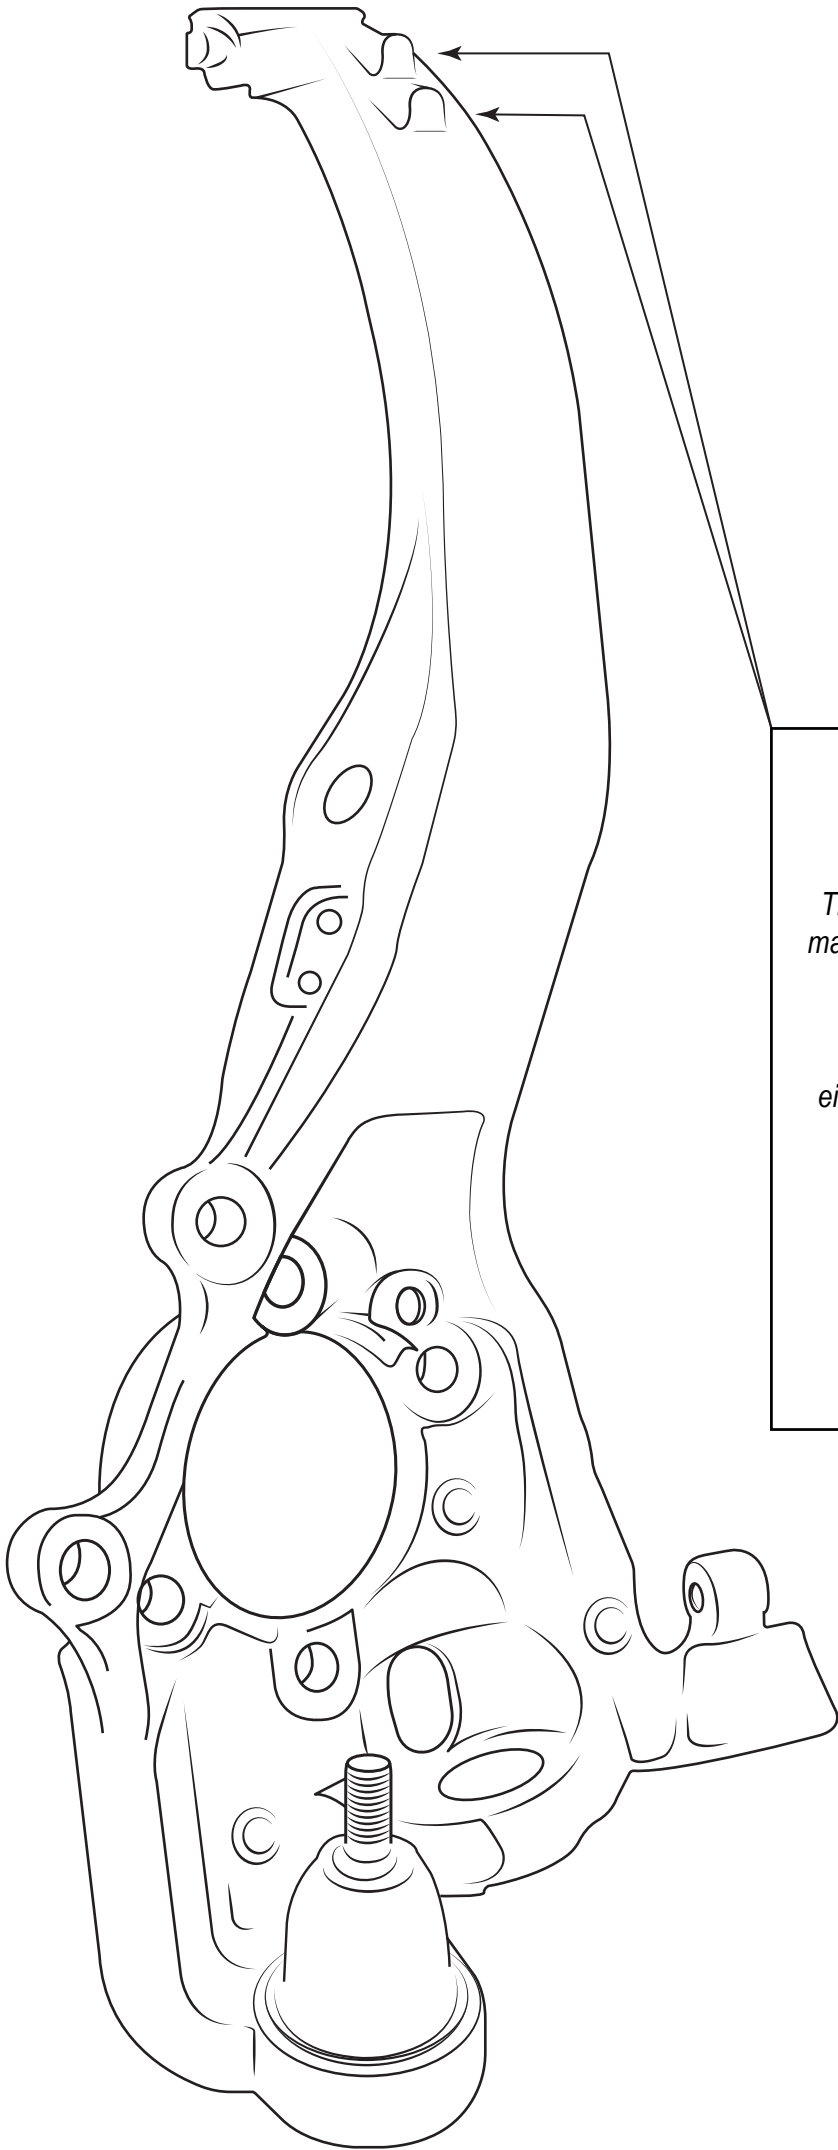
The OEM knuckle has two castings marks that may interfere with the upper camber arms during suspension operation.

This is most commonly seen when running either a low ride height, having soft suspension or when the suspension is compressed and on or near full steering lock.

We do recommend, regardless, grinding the casting marks flush to avoid any possible contact being made.
